## SUBMERGED JETTY PANAMA CITY FLORIDA

## MAPPING COASTAL HAZARDS

# ASTRALiTe EDGE™ - Mapping Coastal Hazards

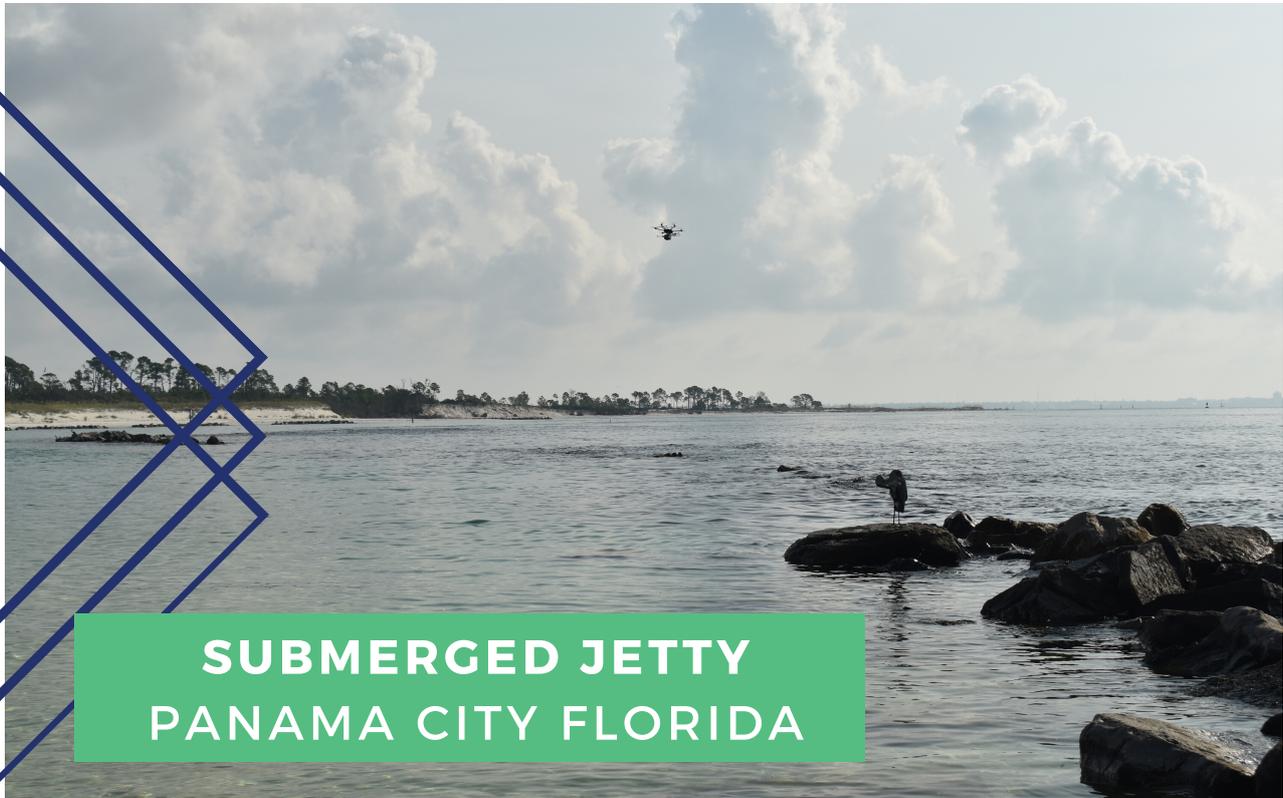
**Monitoring of near-shore change detection is critical for safety of life, commerce, and maintenance of infrastructure, especially after major storms such as Hurricane Michael (Cat 5, Oct 2018).** As seen in these pictures of the Panama City, FL Inlet, displacement and submergence of jetty riprap and severe dune erosion resulted in severe boating hazards and dangerous conditions. The resulting bathymetric change diverts and focuses wave energy in complex ways that can further impact beach and dune erosion as well as boating channel navigation.

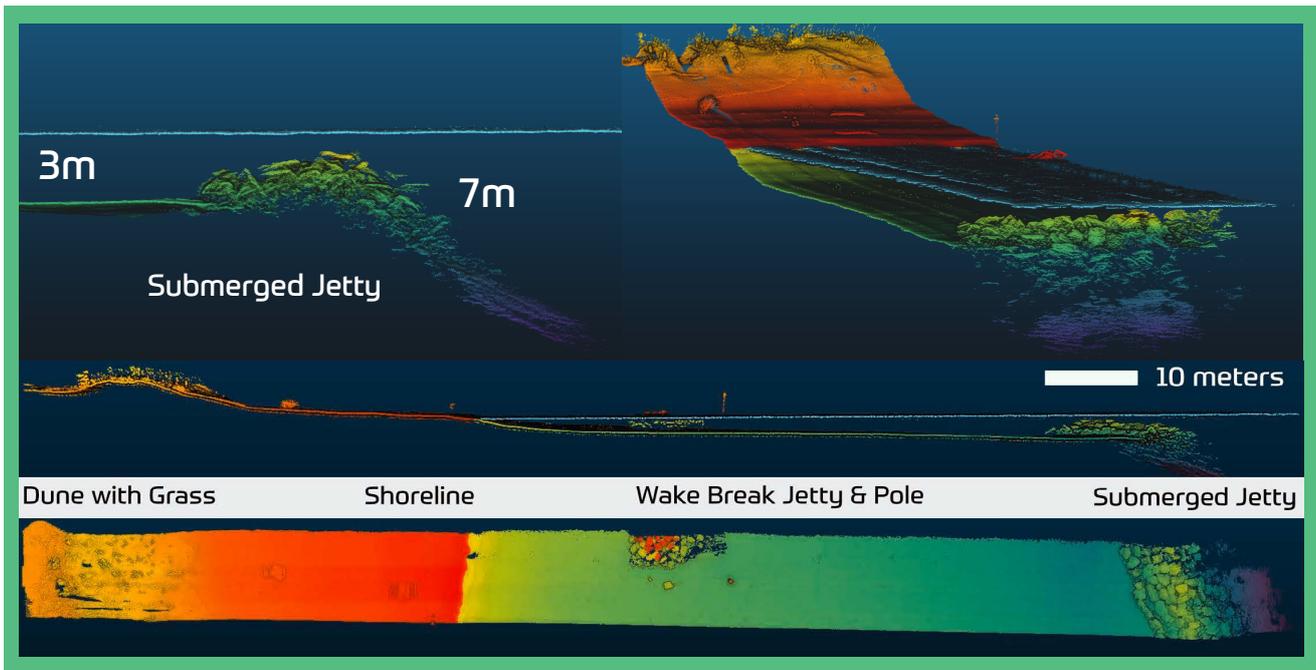
ASTRALiTe's topographic / bathymetric LiDAR has been used successfully in coastal areas to accurately measure shallow water depths, identify the extent, shape, and depth of coral formations, sand bars, and jetties. The ability to identify submerged rocks near the water surface of the Panama City Beach, FL jetty damaged in Hurricane Michael is a prime example of the hazards to shipping channel navigation and danger to people and boats.

**Using the EDGE LiDAR to "paint the scene" underwater, high density point clouds of up to 300pts/m<sup>2</sup> were acquired of the damaged jetties that the US Army Corp of Engineers can now repair.**

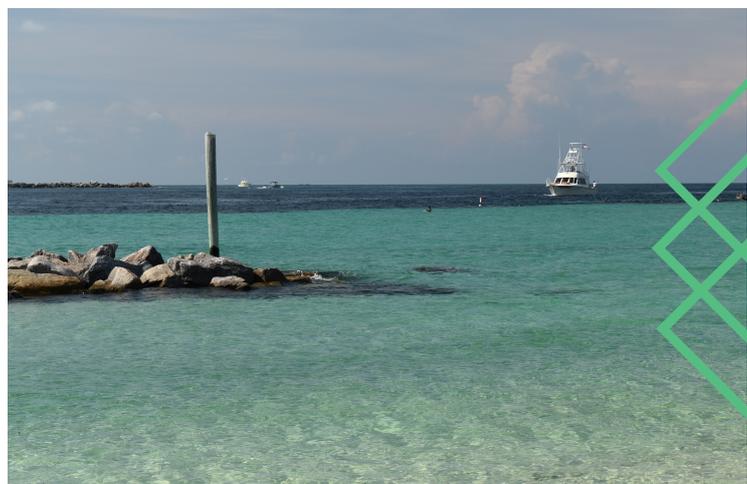
This level of detail also enables object identification by shape for suspended subsurface hazards (e.g., mines or debris), and assessment of infrastructure for structural integrity and potential damage.
